A Lubrication Problem

Amongst the multitude of engines in use on the farm is a twin cylinder Petter Diesel which provides the motive power for a Benford concrete mixer. (Photo 1)

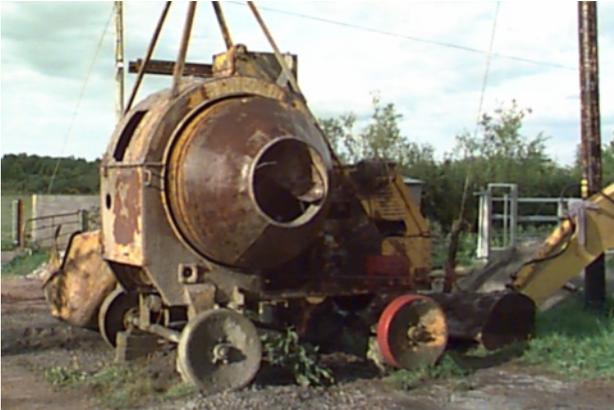
Photo 1: Big Mixey had seen better days, but he had seen worse days too. Life on the farm was more relaxed than it had been in the concrete factory. There was always something of interest happening, and his efforts were invariably much appreciated. The arm and bucket of his friend Big Dog the excavator, are seen at the right of the picture.

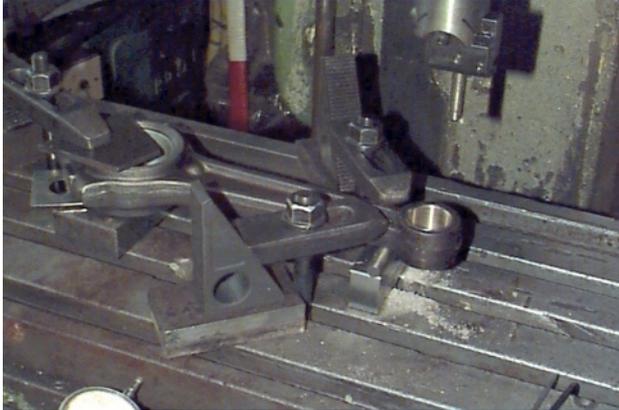
After a number of years use, Bill took it into his head to give Big Mixey's engine a decoke. One thing led to another, and the engine ended up being fitted with new pistons, big end shells, and small end bushes (Photo 5). Oil seals and gaskets were also renewed.

Photo 5: One of the Petter conrods has its small end bored to size on the Cincinnati Mill

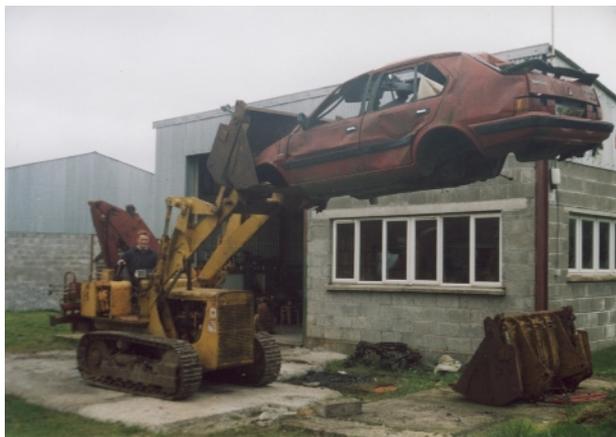
The Petter was far from being fully reconditioned, but the boys adapted a complete air filter system taken from a scrap Volvo (Photo 6) and fitted a silencer which had been recovered from a Daimler V12. Big Mixey was hobnobbing with the vehicular aristocracy.

Photo 6: With Bill at Drotty's controls, the carcass of a thoroughly disreputable looking Volvo, stripped of everything of value, commences its final journey.

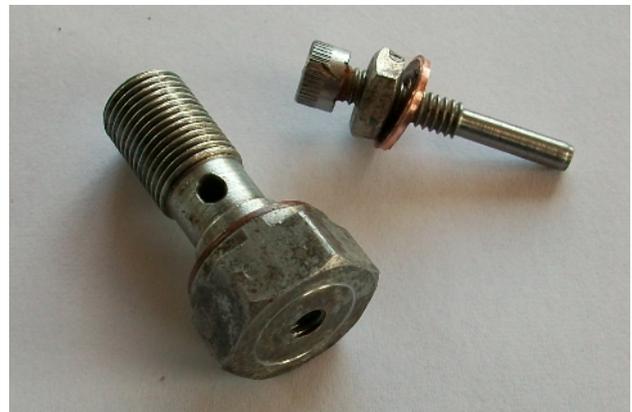
All that I required to do was convert the axial oil passage into a through hole. This was tapped to match a setscrew. The setscrew was turned down to a diameter slightly less than that of the oil passage in the banjo bolt. (Photo 7).

Photo 7: The modified banjo bolt and setscrew.

The position of the setscrew then determined the extent to which the transverse oil passage in the banjo was occluded. Clearance between the bore of the axial oil passage and the setscrew diameter ensured that oil to the rockers could not be shut off entirely.
